# ATLAS MACHINE INSPECTION REPORT

ITEM: CORRECTING ROLL POT RIG BEAM FINAL INSPECTION

JOB # 146611PR

Correcting Roll Beam Inspected After Completing All Machining

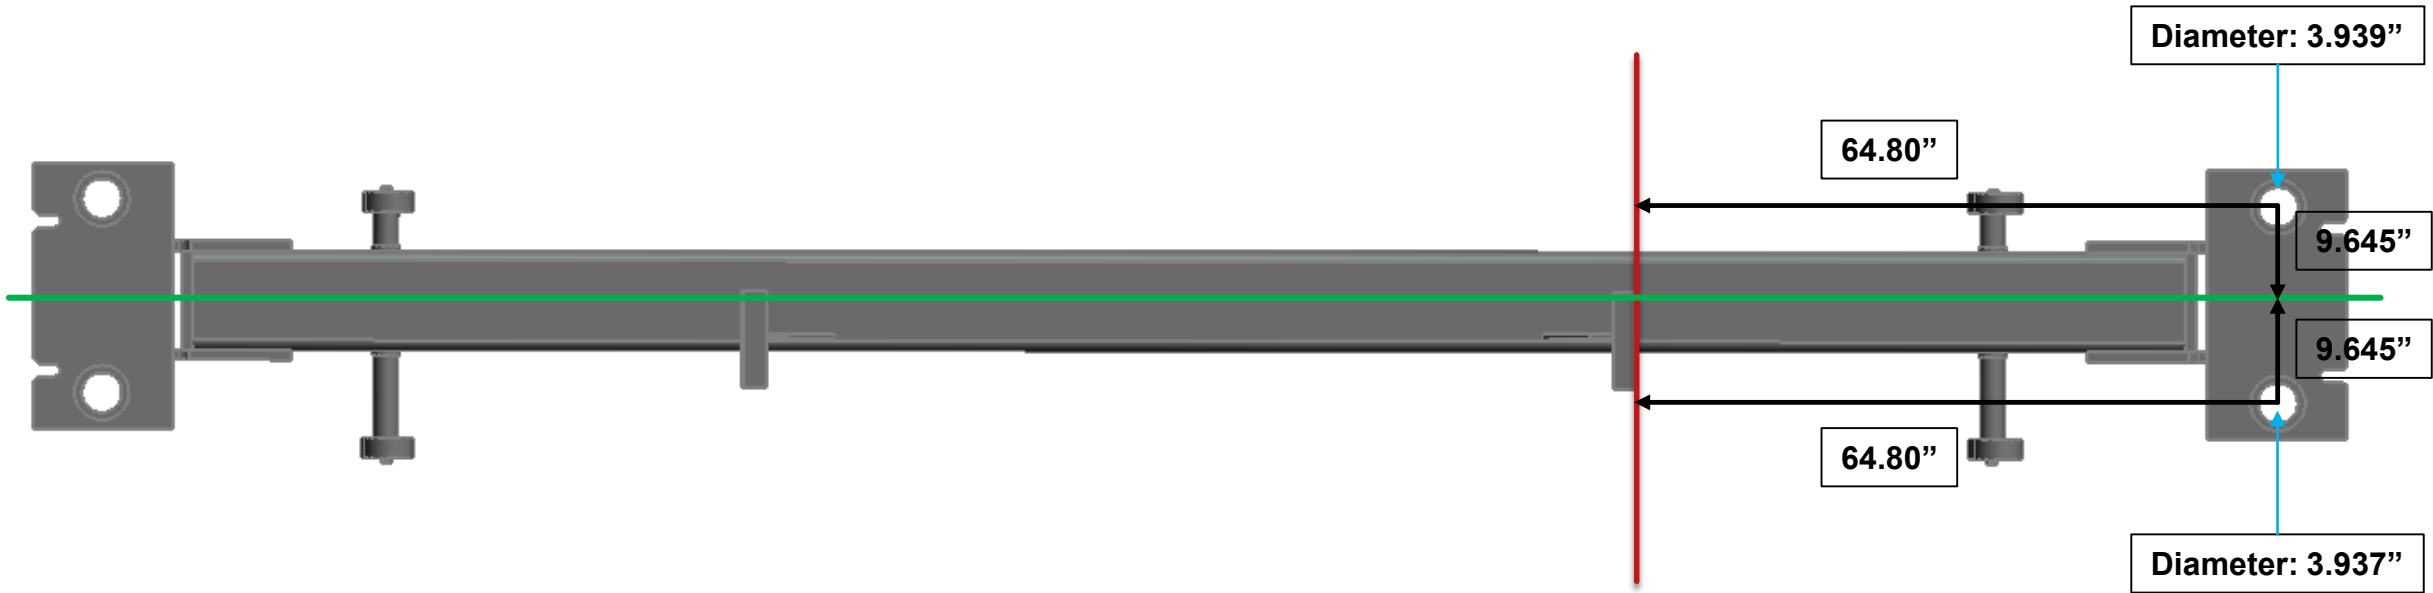
# FIXED END

Fixed End Hole Location WRT Machined Keyway Plane and Centerline of Beam

View: Looking Down at Machined Surfaces

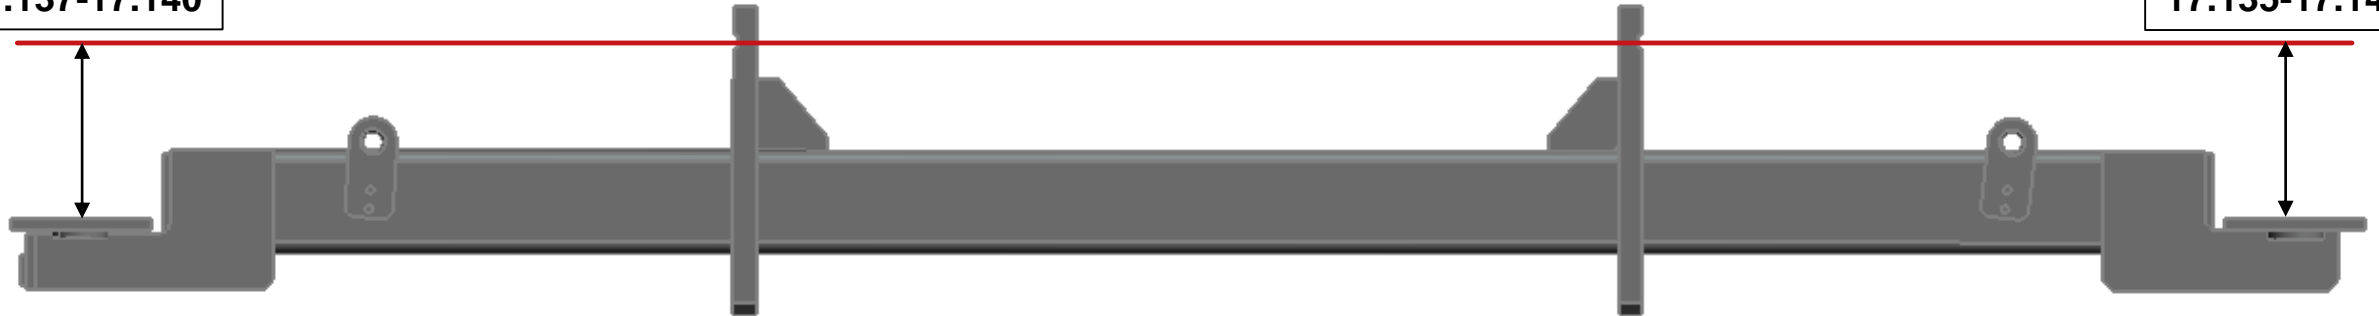
## MOUNTING SURFACE TO KEYWAY

Distance From the Fixed/Floating End Planes to the CL of Keyway

17.137-17.140

17.135-17.142

View: Machined Surfaces Up
